CORROSION BEHAVIOUR OF CLADDING MATERIALS OF RESEARCH REACTOR SPENT FUEL DURING WET STORAGE

*A.H. QURESHI, N. HUSSAIN, M. ARIF, E. AHMED, M. AKRAM and N. K. QAZI

Materials Division, Directorate of Technology, PINSTECH, P.O. Nilore, Islamabad, Pakistan.

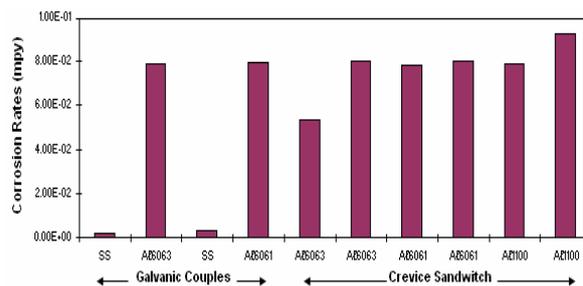
Figure 3. Corrosion rates of galvanic couples and crevice sandwich.

The corrosion rates of specimens after 365 days exposure in the basin water are presented in Fig. 3. These results indicate that the aluminium samples were relatively more affected as compared to stainless steel samples. Visual observation of galvanic samples showed that there were more deposits of scale on aluminium samples as compared to stainless steel (SS) samples. In the crevice couples both aluminium samples (Al + Al) were found almost identical with respect to scale deposits on their surfaces.

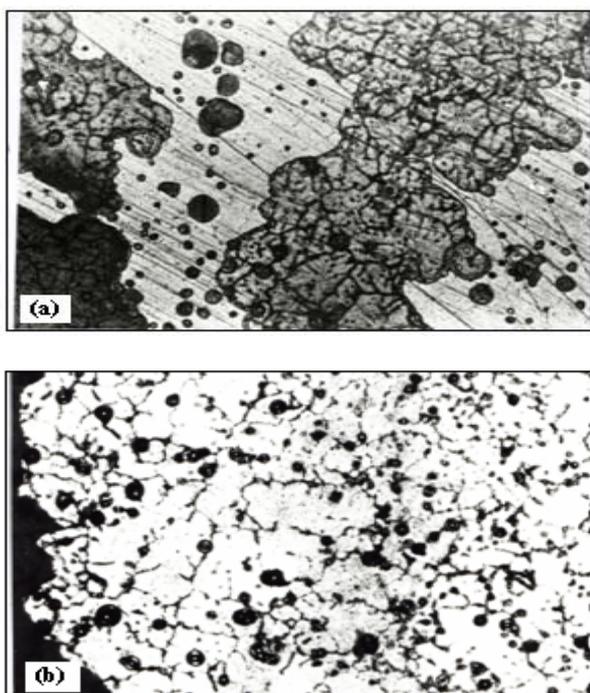
Figure 4. Micrographs of galvanic couple (a) Aluminium 6063/114 exposed surface and (b) Aluminium 6063/143 exposed surface.

Exposed specimens of galvanic couples were observed under optical microscope. In stainless steel sample (SS316/112) no pitting and deposition were observed. Only boundary marks of insulating washer and some scratches which had occurred during assembling on the specimens. In sample Al6063/114 (surface exposed to water) areas under washer remained bright but showed pitting of 4µm under washer surface. These pitting were mostly round, elliptical, shallow and a few undercutting as shown in Fig. 4a. No pitting was observed on the coupled surface. In other galvanic couples the stainless steel sample (SS316/119), in the surface exposed to water, a band of etched out area as a boundary line (without any pitting) was produced under and along the outer edge of insulating washer. On the coupled surface some steaks of scale 2µm thick formed due to seepage of water. However, on the surface of the sample Al6061/143 (exposed to water surface) 6 to 20µm deep pitting was observed only under ceramic washer, mostly having round openings and grain boundaries were also etched out as shown in Fig. 4b. No pitting on coupled surface was observed.

Sp.#	Microscopic Observations
Galvanic couple	316/112	No pitting and deposition only boundary marks of insulating washer and some scratches which had occurred during assembling on the specimens
	6063/114	Pitting of 4 μm under washer surface. These pitting were mostly round, elliptical, shallow and a few undercut (Fig. 4a).
Galvanic couple	316/119	On the surface exposed to water, a band of etched out area as a boundary line (without any pitting) and on the coupled surface some steaks of scale 2 μm thick formed due to seepage of water
	6061/143	On the surface exposed to water, 6 to 20 μm deep pitting under ceramic washer (Fig. 4b). No pitting on coupled surface was observed.
Crevice sandwich	6063/167	Pitting (round & irregular) of 8 to 18 μm (Fig. 5a) under ceramic washer. Pits of 2 μm depth on coupled surface (Fig. 5b).
	6063/187	No pitting on exposed surface. On the coupled surface scale formed at some areas due to water seepage, while other areas remained bright and un-attacked

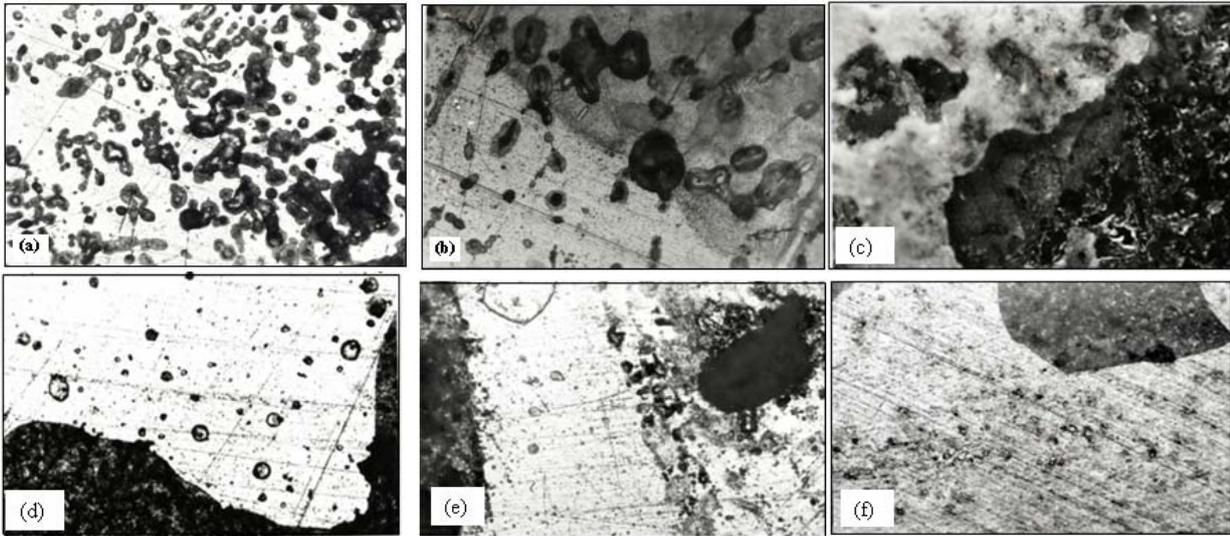
Figure 5. Micrographs of crevice sandwich of exposed surfaces of Al specimens (a) 6063/167 (b) 6063/167 coupled surface (c) 6061/241 (d) 6061/237 (e) 1100/228 (f) 1100/221.

In the first crevice sandwich (Al6063/167-Al6063/187) of aluminium the top surface under ceramic washer of sample Al6063/167 having round & irregular shape of pittings 8 to 18 μ m in size and mostly found at grain boundaries as shown in Fig. 5a. Some shallow pits of 2 μ m depth were observed on coupled surface while most of the area remained un-attacked, (Fig. 5b). In the case of sample Al6063/187 no pitting was observed on exposed surface. On the coupled surface scale formed at some areas due to water seepage between two coupled surfaces while other areas remained bright and un-attacked.

In the second crevice sandwich (Al6061/241 and Al6061/237), the area under insulation washer of sample Al6061/241 has showed some pealed off scales where region without scale showed very shallow pits are shown in Fig. 5c. The thickness of scale was measured which is about 10 μ m thick on the exposed surface. No pitting observed on the coupled surface and areas in contact with each other remained bright. In sample Al6061/237 the pits with maximum 20 μ m depth were observed in the area remained under insulation washer

(Fig. 5d). Uniform scale observed along the water channels on the surface exposed to water.

In the third crevice sandwich (Al1100/228 and Al1100/221) a few undercut type of pits 10 to 16 μ m deep were found in the sample Al1100/228 (Fig. 5e). The dense scale at surface exposed to water was observed and no appreciable pitting found. In the sample, Al1100/221, thick and uniform scale observed on the exposed surface (Fig. 5f). Contact areas (Coupled surface) remained bright and no pitting was observed either on exposed or coupled surfaces.

As discussed before the results of water analyses have indicated that the water quality meet up the standard requirements. However, it seems that the water chemistry in the crevice (for Al-Al samples) could be more aggressive than that of the pool, and it would determine the susceptibility to pitting. In addition to water chemistry parameters other factors may also play a vital role to promote pitting of aluminum alloys [17-19] such as high conductivity of pool water, aggressive ions, sludge having concentrated Fe⁺⁺⁺ and Cl⁻ impurities, scratches/imperfections in protective oxide film.

Crevice sandwich	6061/241	The area under insulation washer showed some peeled off scales where region without scale showed very shallow pits (Fig. 5c). No pitting on the coupled surface
	6061/237	Pits with maximum 20 μm depth in the area remained under insulation washer (Fig. 5d). Uniform scale observed along the water channels on the surface exposed to water
Crevice sandwich	1100/228	A few undercut type of pits 10 to 16 μm deep on coupled surface (Fig. 5e). No appreciable pitting on surface exposed to water
	1100/221	Thick and uniform scale on the exposed surface (Fig. 5f). Coupled surface remained bright and no pitting
